INDOOR AIR QUALITY ASSESSMENT

**Agape Christian Academy
620 Washington Street
Winchester, Massachusetts**

Prepared by:
Massachusetts Department of Public Health
Center for Environmental Health
Emergency Response/Indoor Air Quality Program
June 2006

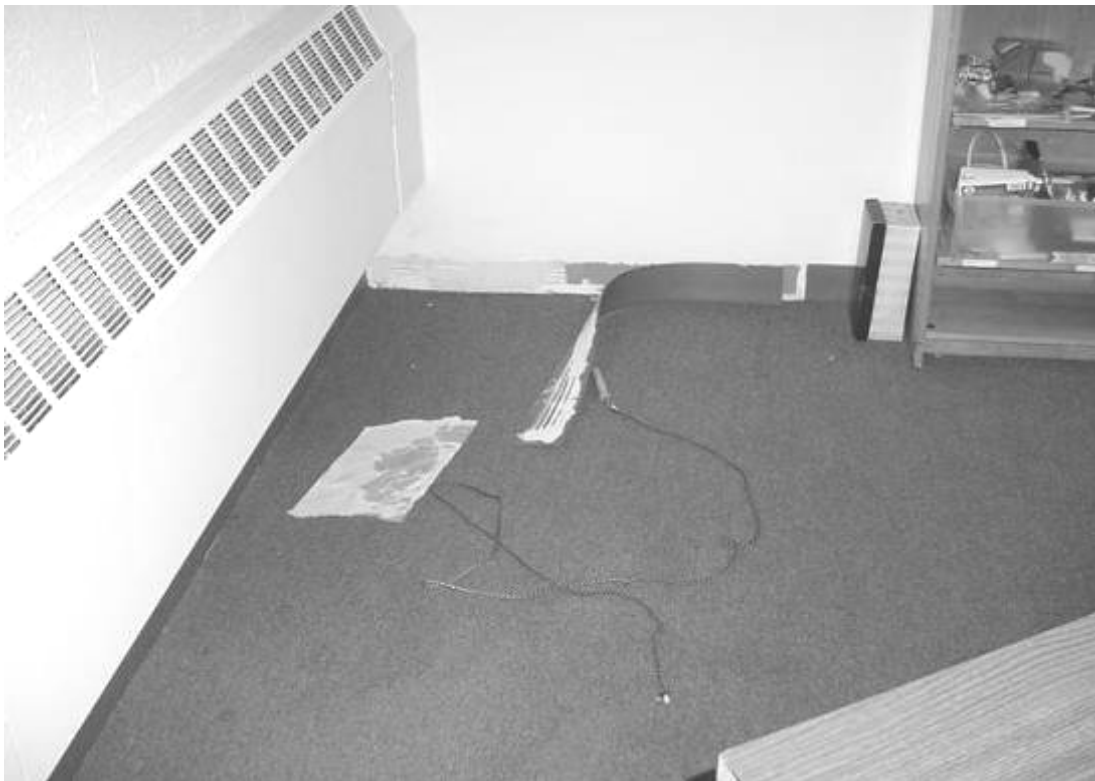
Picture 1

Upon entering the building a distinct musty odor was noted, which increased in intensity upon approaching room 105 (K5). Room 105 had carpeting which was saturated with water that dampened a paper towel placed on the surface (Picture 1). In addition, GW located around windows was heavily moistened to a point where plastic coving was easily peeled from the wall (Picture 2).

The US Environmental Protection Agency (EPA) and the American Conference of Governmental Industrial Hygienists (ACGIH) recommends that porous materials be dried with fans and heating within 24 to 48 hours of becoming wet (US EPA, 2001; ACGIH, 1989). If porous materials are not dried within this time frame, mold growth may occur. Once mold growth has occurred, disinfection of these materials may be possible. Since GW and carpeting are porous surfaces; disinfection is likely to be ineffective. Removal of these materials is likely needed to prevent exposure to mold and other associated pollutants.

Wet Carpet, Room K5, Note Wet Paper Towel Placed on Floor by CEH Staff

4. Remove water damaged materials (e.g., carpeting, gypsum wallboard and wall insulation) in a manner consistent with recommendations found in “Mold Remediation in Schools and Commercial Buildings” published by the US Environmental Protection Agency (US EPA, 2001). Consider replacing carpeting with a non-slip, nonporous material (e.g., rubber matting, tile).

5. Once carpet is removed, use ventilation and dehumidifiers to draw moisture from the cement floor that exists above the slab vapor barrier.
6. If possible, relocate susceptible persons and those with pre-existing medical conditions (e.g., hypersensitivity, asthma) away from the general areas of remediation until completion.

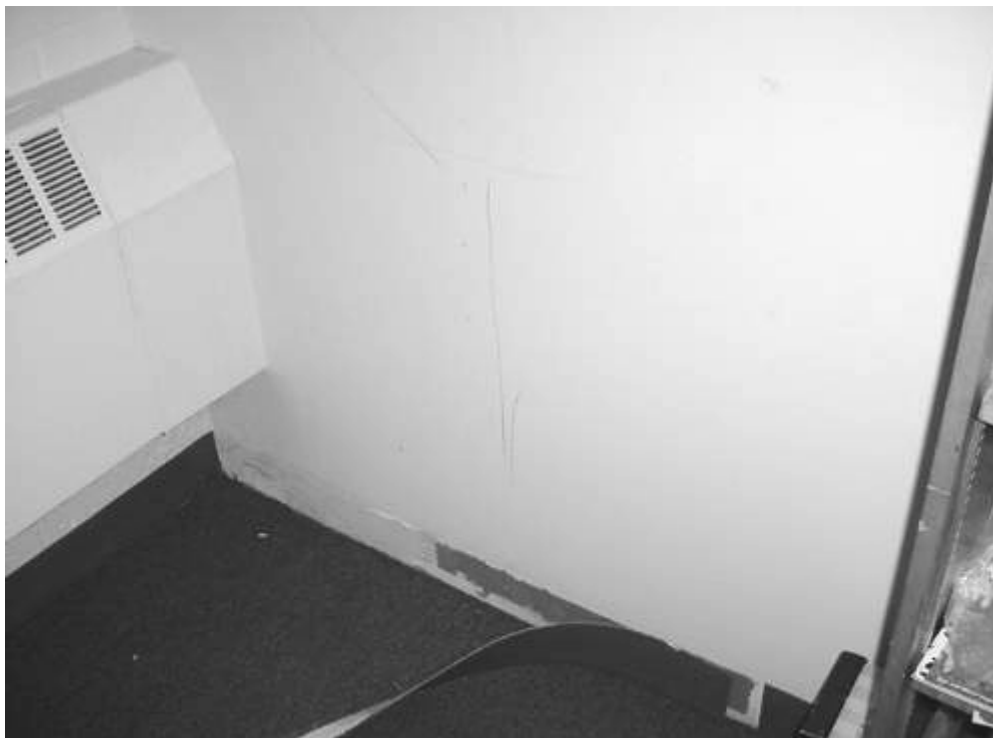
Picture 2

Plastic Coving Easily Peeled From Wall, Lines Denote Area of Obvious Wet GW

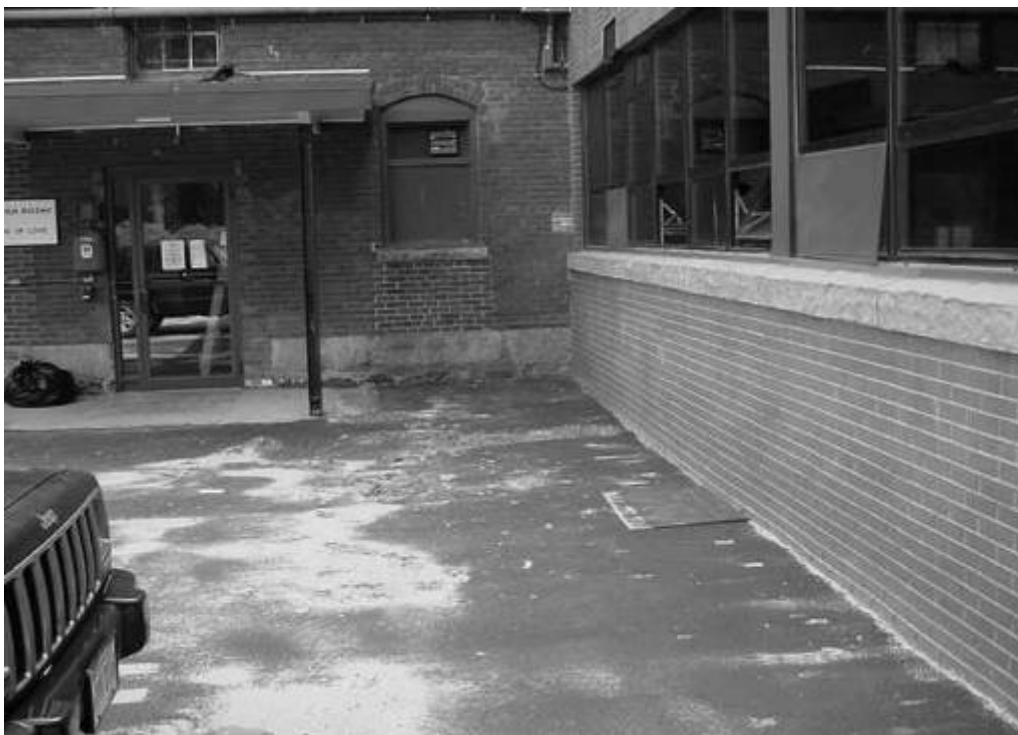
Picture 3

In order for building materials to support mold growth, a source of water exposure is necessary. It is likely that the source of the water moistening building materials was from rainwater accumulated against the corner of the building (Picture 3). It appeared that a section of the roof directs rainwater into this corner. Evidence of heavy water accumulation was observed in this area, including tarmac erosion (Picture 4), moss growth on brick mortar (Picture 5) and breaks in sealant used to join the two building wings (Picture 6). Any seam or crack in the exterior could provide a pathway for driving rain to penetrate the building interior and produce the damage noted in room 105.

Exterior Wall outside Room K5

- Install a gutter/downspout beneath the roof edge to direct water away from the building edge. Such a system should be of sufficient drainage capacity to handle large downpours.
- Remove moss and repair mortar of brickwork outside room K5
- Repair the joint between the building wings.
- Repair tarmac outside room K5 and regrade surface to direct water from the exterior walls of the building.

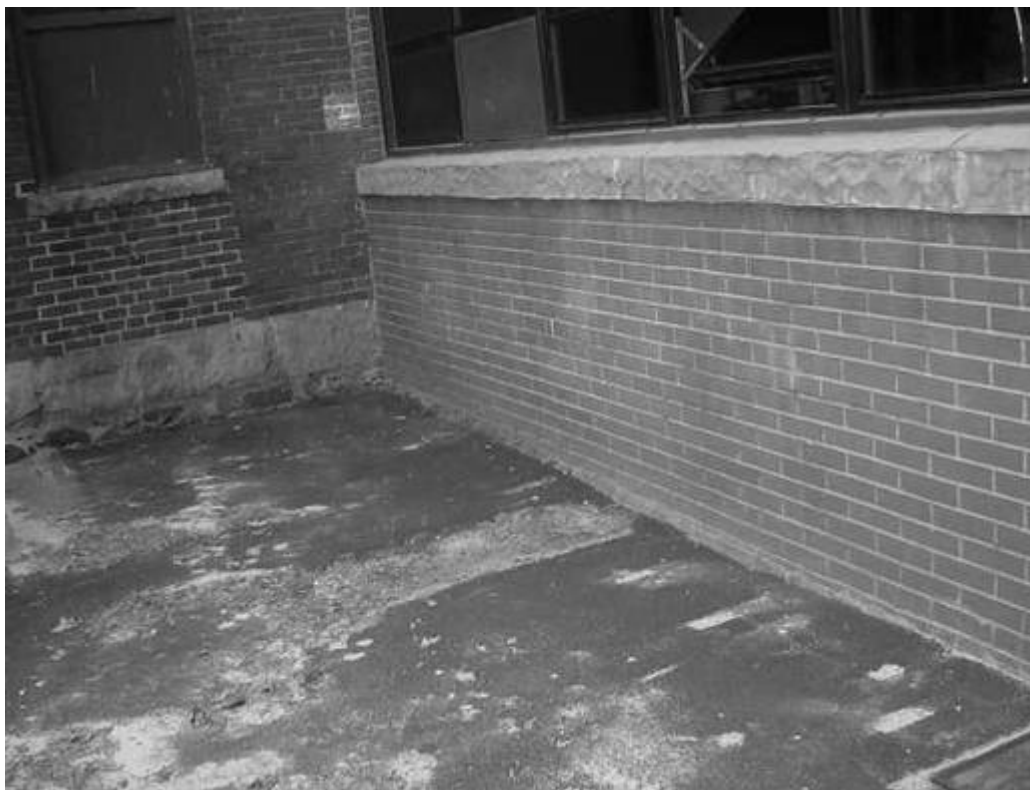
Picture 4

Tarmac Erosion from Water Impact from Roof

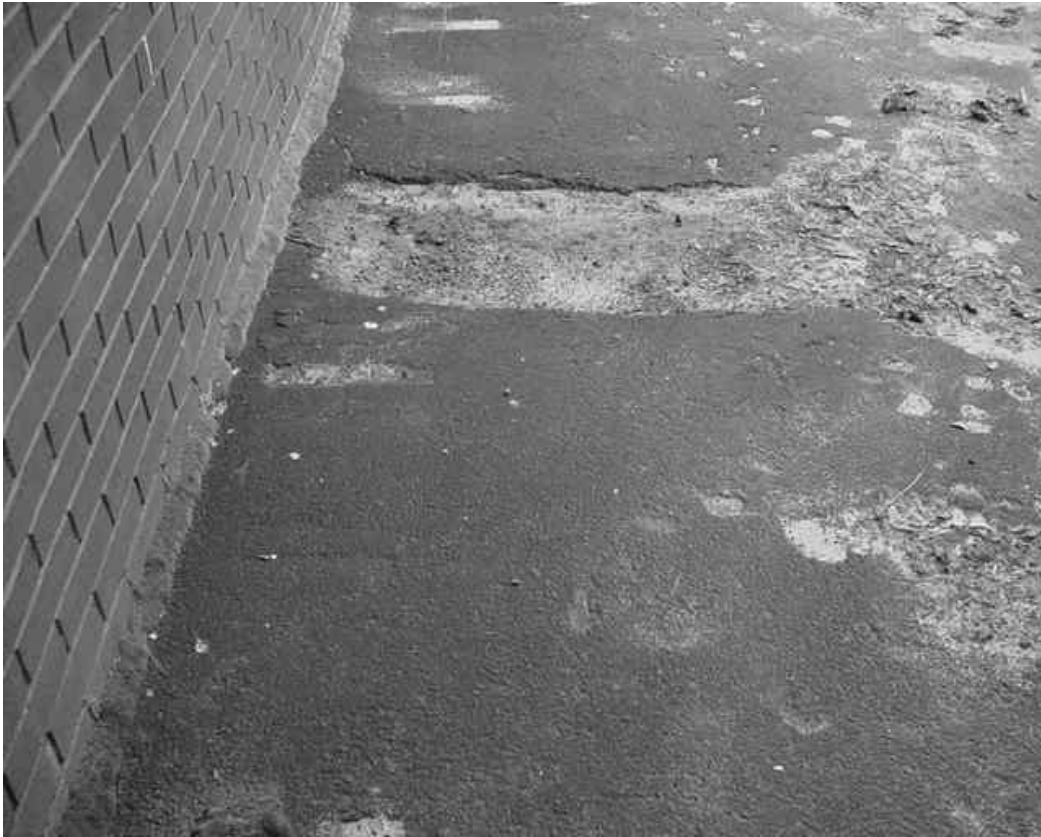
Picture 5

Moss on Brick Mortar outside Room K5

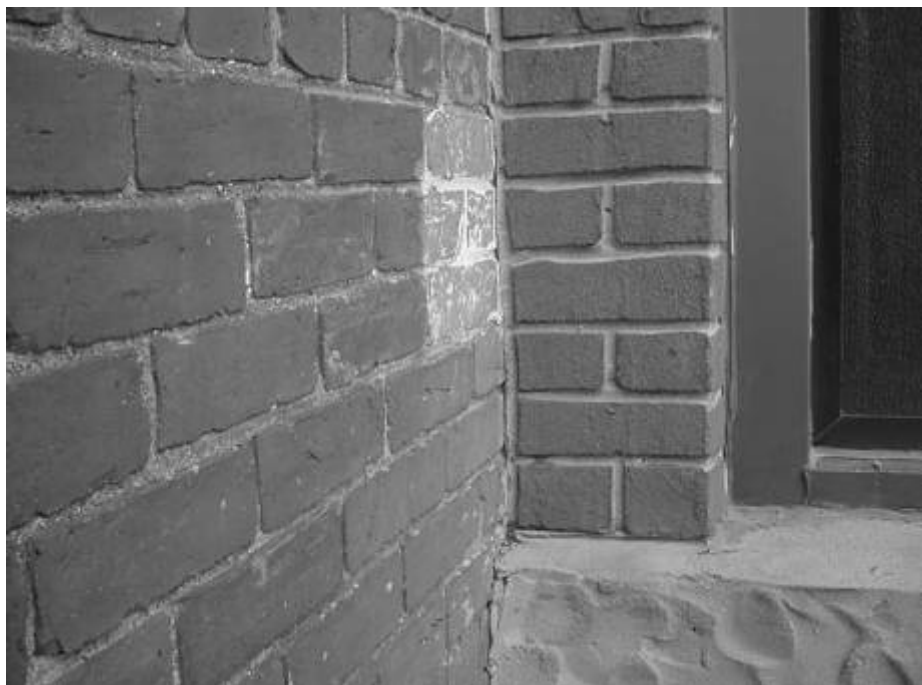
Picture 6

Missing/Damaged Sealant between Building Wings

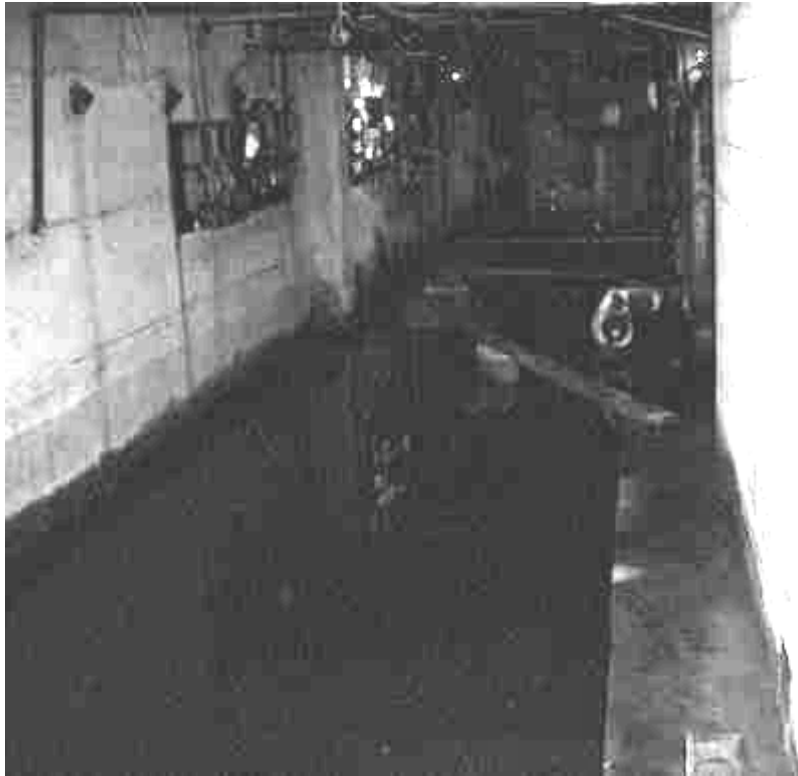
Picture 7

“Oil-like” odors were also reported by local health officials prior to the CEH assessment. The elevator mechanical room is located in the basement, which was under several inches of water from a pipe/culvert break. The furnace and other equipment was also under water (Pictures 7 through 9). It is possible that water may have dislodged spilled oil from machinery surfaces or hydraulic fluid from the elevator motor, which initially resulted in “oil-like” odors reported in the front of the building. No oil odors were detected by CEH staff during the assessment.

ACA Flooded Basement

1. Deactivate all electric equipment in the basement.
2. Seal the elevator shaft with polyethylene plastic and duct tape to prevent basement odor migration to the first floor.

14. Repair the source of water flooding the basement, which may include the following actions:

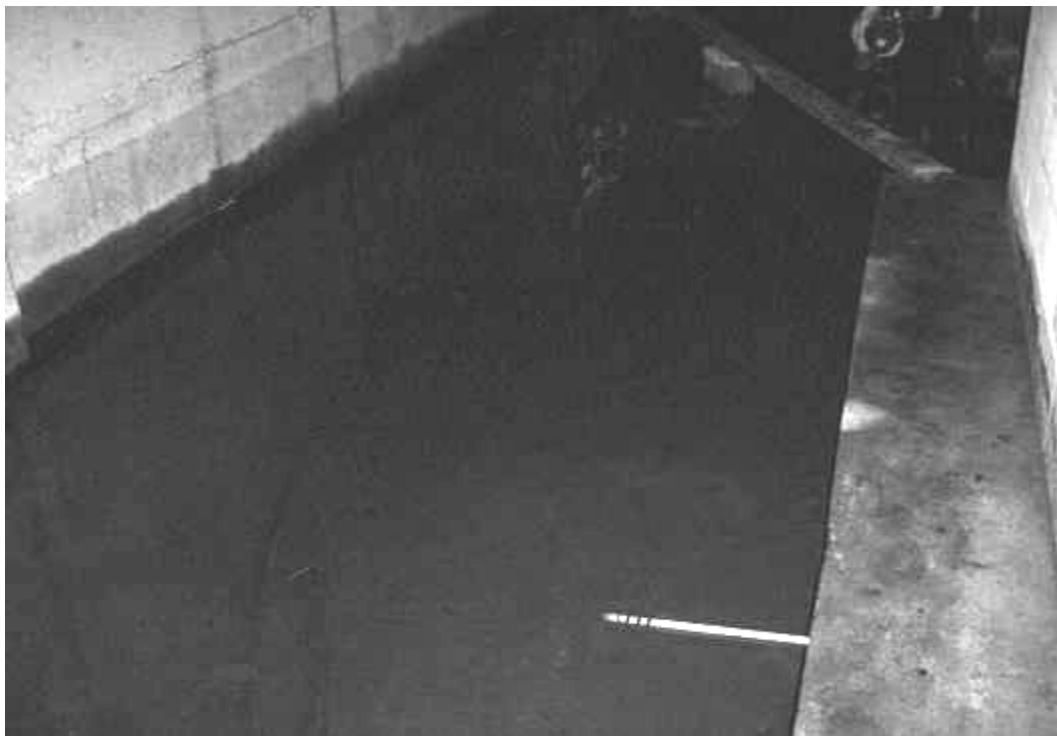
Picture 8

ACA Flooded Basement

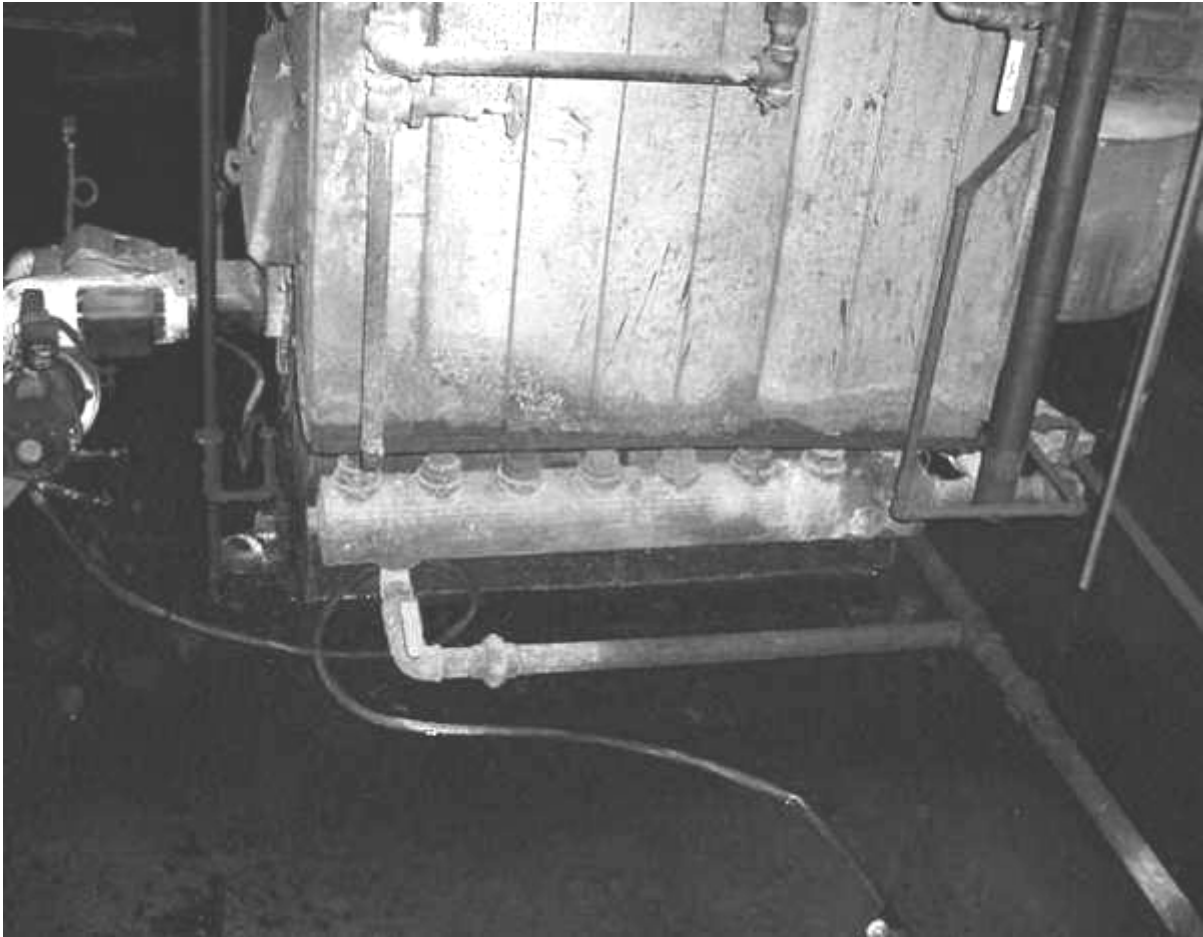
Picture 9

Furnace, ACA Basement
